National Transportation Safety Board
Office of Marine Safety

Group Chairman's Factual Report
Engineering and Operations

Accident Number: DCA-01-MM-022

Accident No.: DCA01MM022
Vessels Involved: USS *GREENEVILLE* & MV *EHIME MARU*
Location: About 9 miles south of Oahu, Hawaii
Date: February 9, 2001
Time: 1343 HST¹

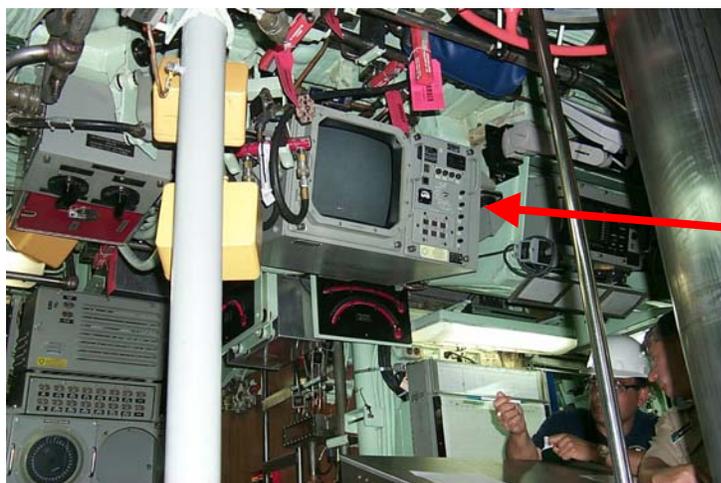
AVSDU located above the OOD watch station

Figure 1 – Sonar display located in control room (AVSDU) (U.S. Navy Photo)

...[the quality of data is degraded,] obviously with the AVSDU out and no CEP as a backup. You now have--your options are now further limited and you're now almost obligated to spend more time at fire control or physically going into Sonar and looking at the displays in the Sonar Room itself.⁷³

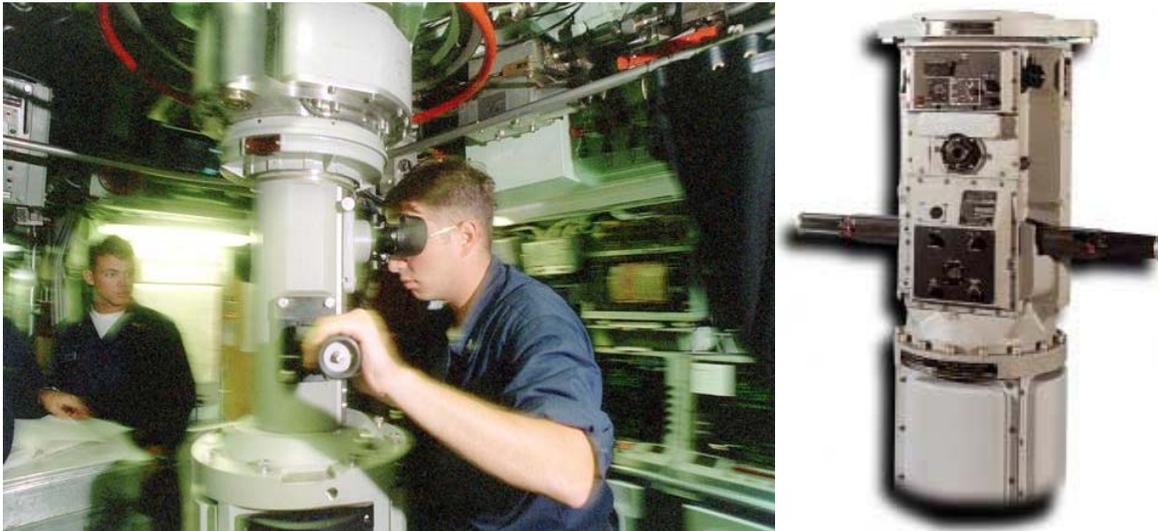
Figure 4 and 5 - Periscope in raised position (U.S. Navy photo)

According to the information provided by the NAVSEA, neither the of *Greeneville's* periscopes had radar capability. However, radar capability had been initially incorporated into submarine periscopes during World War II. The standard periscopes in the 1950's were a Type 2 attack periscope and the Type 8 search periscope, which included an ST band radar antenna. The radar antenna was mounted at the outboard the end of the periscope and was used in a "point and shoot" mode to determine contact ranges. Training the periscope provided azimuth control and bearing information. The periscope did not continuously scan like a conventional navigation or search radar. The Type 8 periscope was installed on all US submarines until the introduction of the Type 15 search periscope that incorporated better electronics warfare capabilities. Type 8 and Type 15 optical designs are identical. The Type 15 became

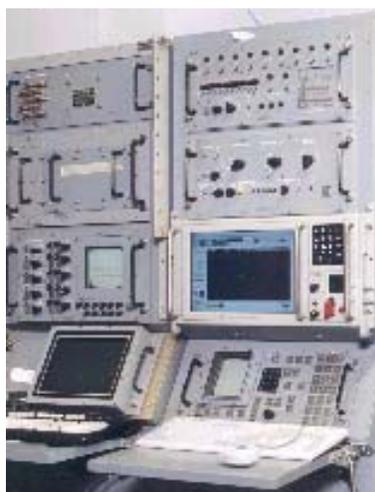
**Figure 6 ESM System
(U.S. Navy photo)**

A second witness at the U.S. Navy Court of Inquiry testified that the reason why the ESM system failed to detect the Ehime Maru as a close contact was unknown:

ESM propagation is subject to some vagaries just like sonar is. There can be skipping, there can be over, you can bypass the mast, it could be ducted away. But under normal conditions, which I think this day was fairly, oh the weather was a little off, little cloudier than normal around Hawaii, but I don't know of any anomalies that would prevent the signal from reaching the periscope. The antenna--ESM antenna on the boat is actually on the very top of the periscope that they were using. And I don't know of any reason why that signal should not have been there. ... I have had--the ESM suite on the ship has been checked out materially, it's--all the bands sweep well, except one of the bands, which was a higher band than the *Ehime Maru's* radar would have been in. That band showed some degradation. But the appropriate receivers for that--that would detect that radar were within specifications, so I don't know a reason why we didn't detect that on ESM.¹⁰³

The former commanding officer of the *Greeneville* stated that he did not know why the ESM failed to detect the Ehime Maru, but thought the Ehime Maru radar may have been finely tuned and did not have the typical side and back lobes that facilitate identification of a close contact, that the high density of nearby radars and the short amount of time allowed for the ESM operator to analyze the signals may have contributed to the cause.

... our ESM, the Whirly 8, that thing is a dinosaur and a piece of crap when it comes to electronic surveillance intercept. Chronically burning cards and material problems with it, and you have to be almost a genius to figure out how to troubleshoot, fix, and repair it. And there are a select few individuals in this world who know how to do that.¹⁰⁵

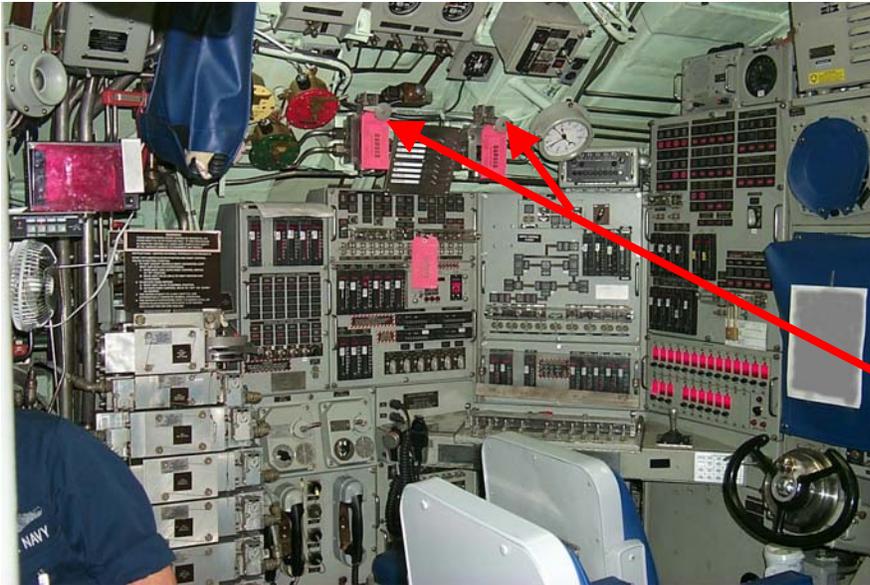
Pilot valves for EMBT blow system above ballast control station – red danger tags hung on activation levers

Figure 7 - Ballast control console and EMBT blow activation valves (US Navy photo)
